SIXTH ENDORSEMENT on VP-24 AAR ser 3-56 concerning FJ-3 BuNo 136153
accident occurring 30 April 1956, pilot (b) (6)

Subj: VP-24 aircraft accident occurring 30 April 1956

FIFTH ENDORSEMENT on VF-24 AAR Ser 2-56 concerning FJ-3, 136152,
accident occurring 30 April 1956, pilot (b) (6)

THIRD ENDORSEMENT on VF-24 AAR Ser 2-56 Concerning FJ-3 BuNo 138163
accident occurring on 30 April 1956. Pilot (b)
(b) (6) LTJG, USN (c)

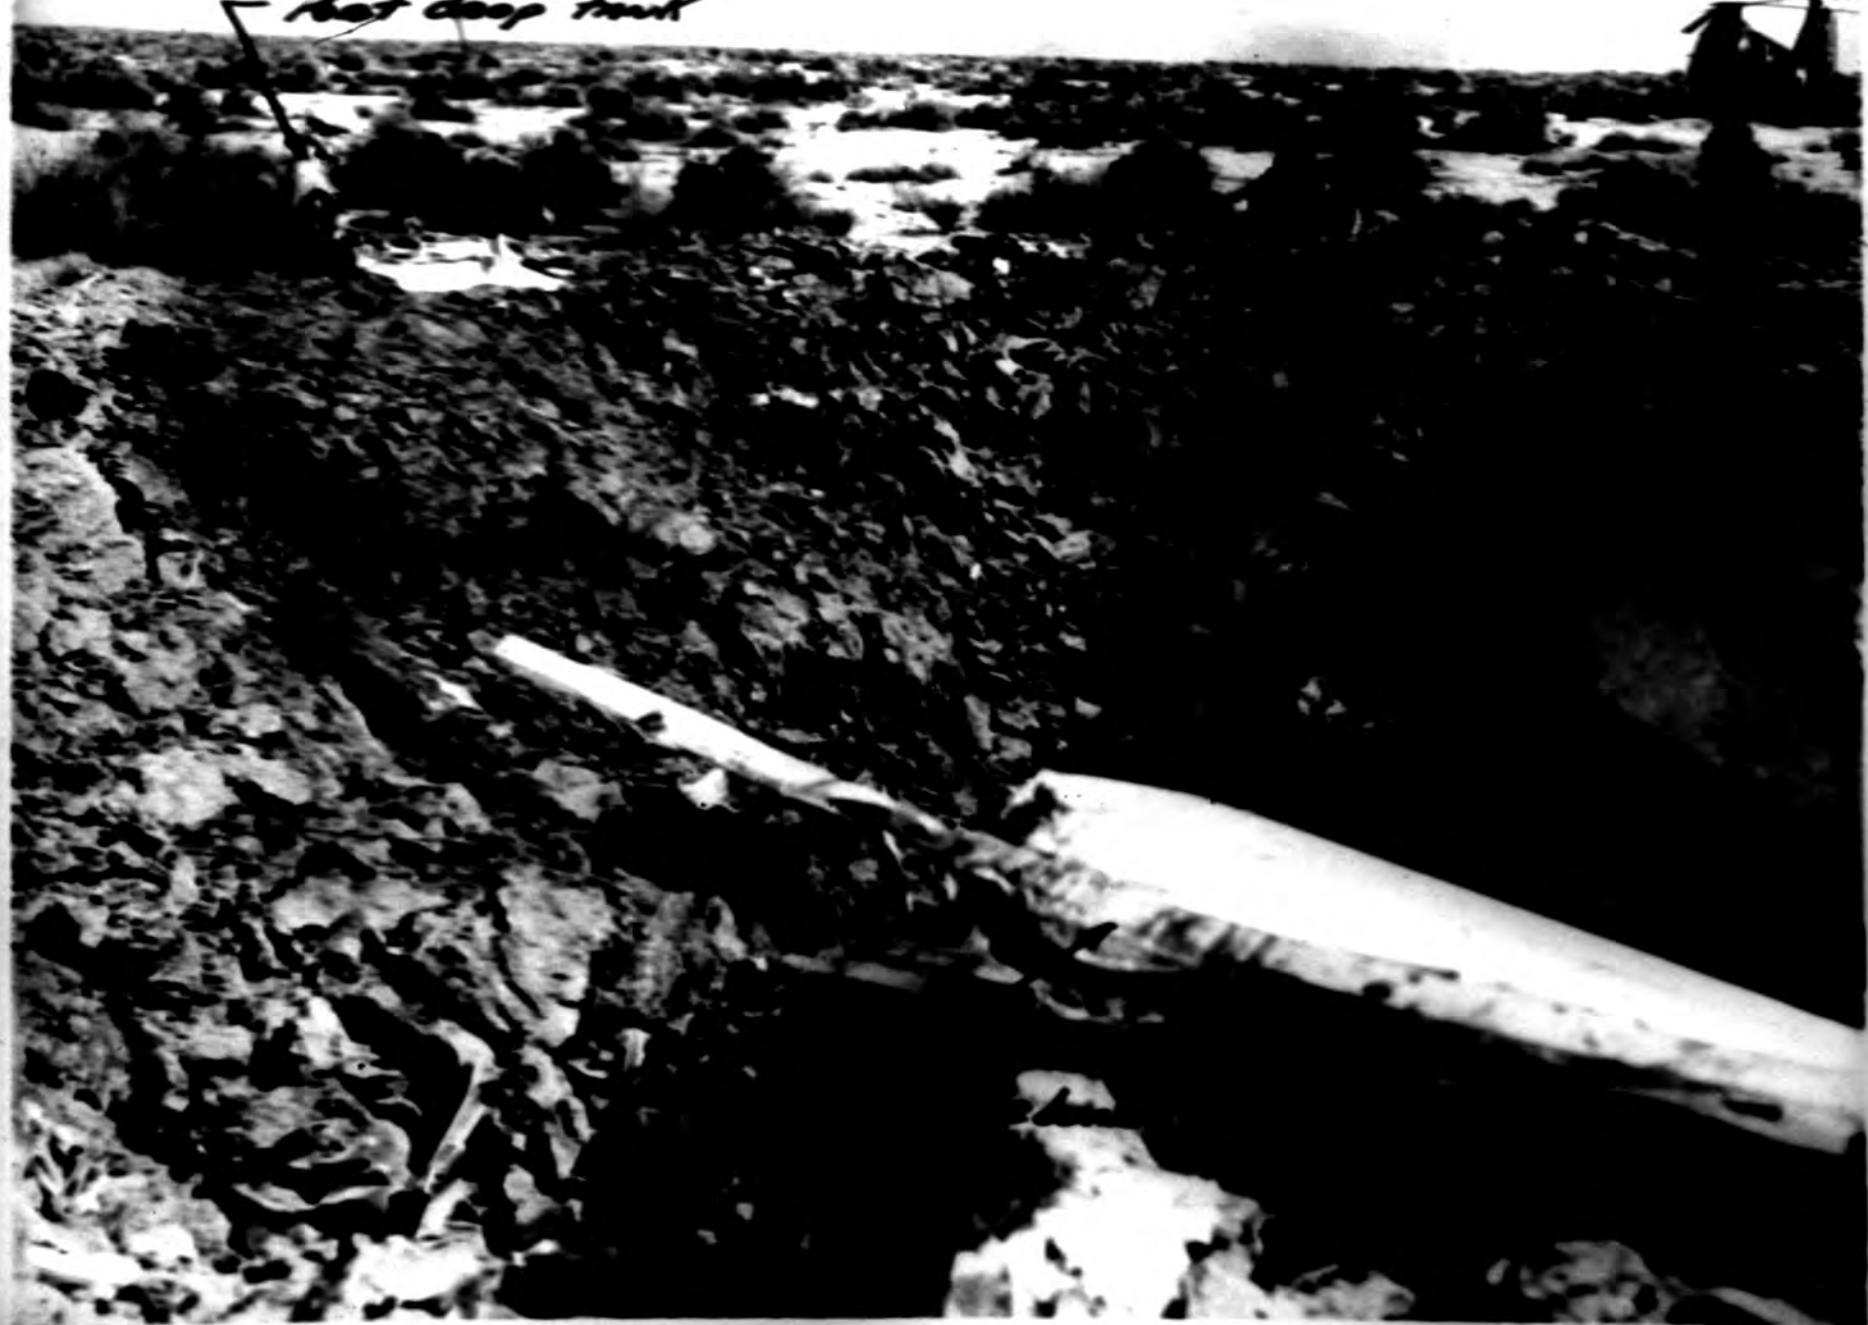
g. The aircraft struck the ground in about 80 degrees nosedown attitude and disintegrated upon impact. Investigation of the area indicated an explosion (see enclosure (5) which shows two areas of debris) but there was no evidence of fire. Debris was thrown forward along the flight path and to the left about 130 degrees from the flight path.
